# RHINOPHALT® CASE HISTORY

## AUTOMOTIVE TESTING PAPENBURG (ATP)

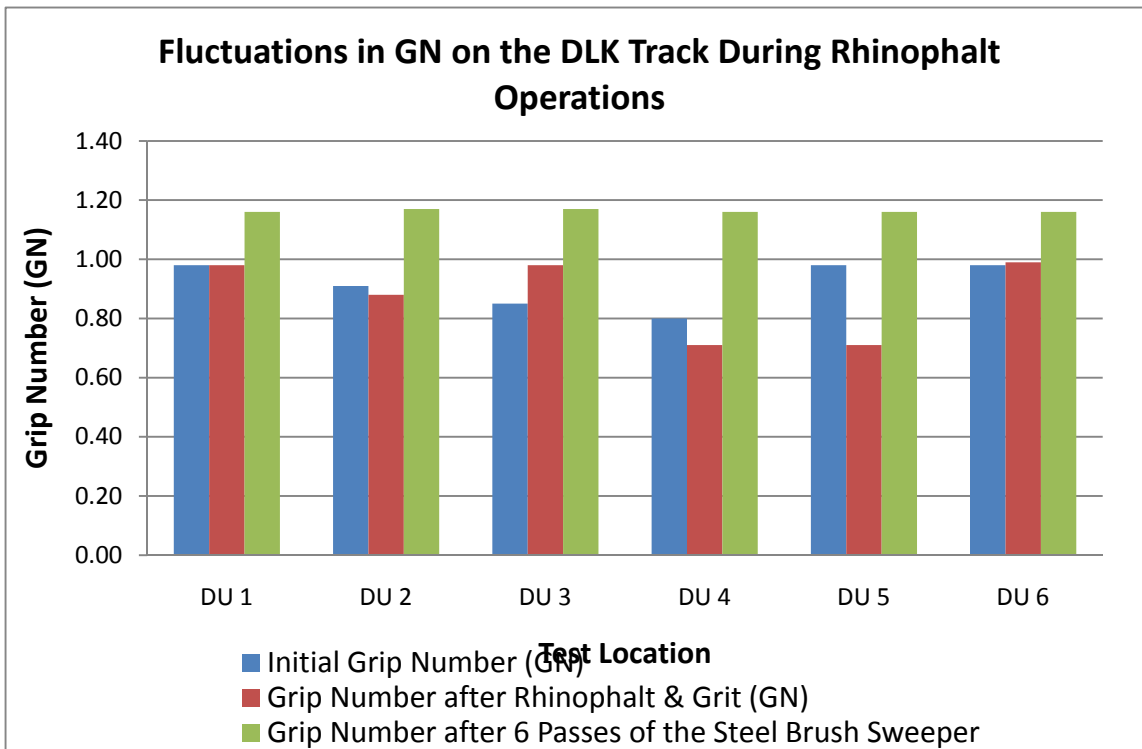
**DLK – DURABILITY TRACK: IN-SITU GRIP NUMBER DURING RHINOPHALT PRESERVATION USING THE MICRO GRIP TESTER**

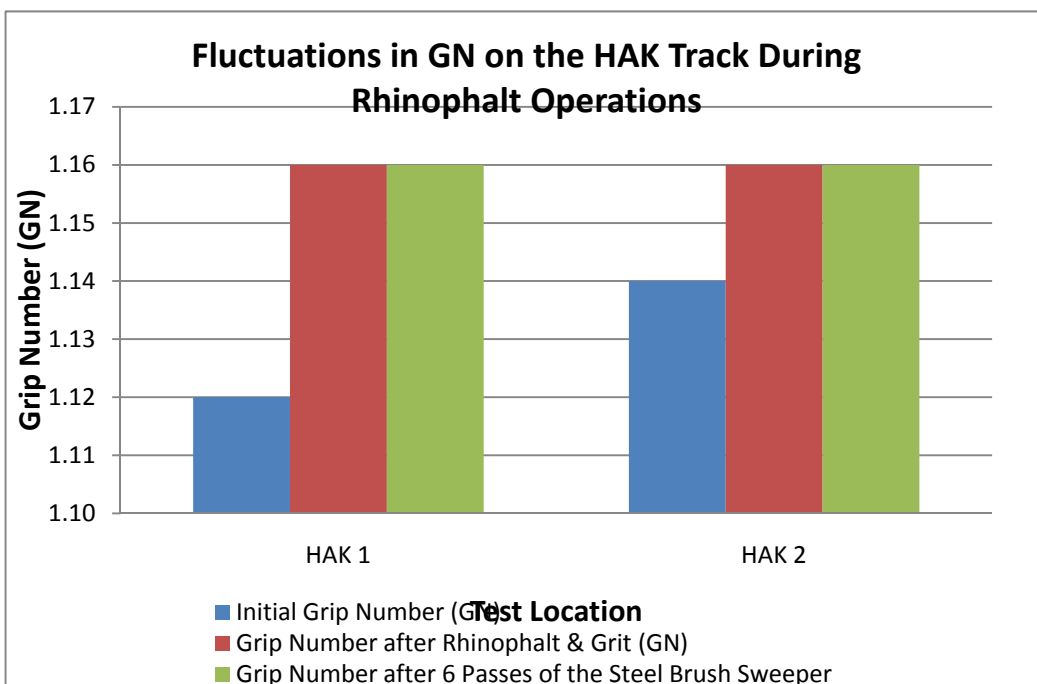
**HAK – HANDLING TRACK: IN-SITU GRIP NUMBER DURING RHINOPHALT PRESERVATION USING THE MICRO GRIP TESTER**
